FINAL REPORT ON –
“INVESTIGATION OF THE
HOUSE LOSSES IN THE
ROLEYSTONE/ KELMSCOTT
BUSHFIRE 6 FEBRUARY 2011”

BUSHFIRE & ENVIRONMENTAL PROTECTION
BRANCH

AUTHOR: RALPH SMITH

DATE: 10 NOVEMBER 2011

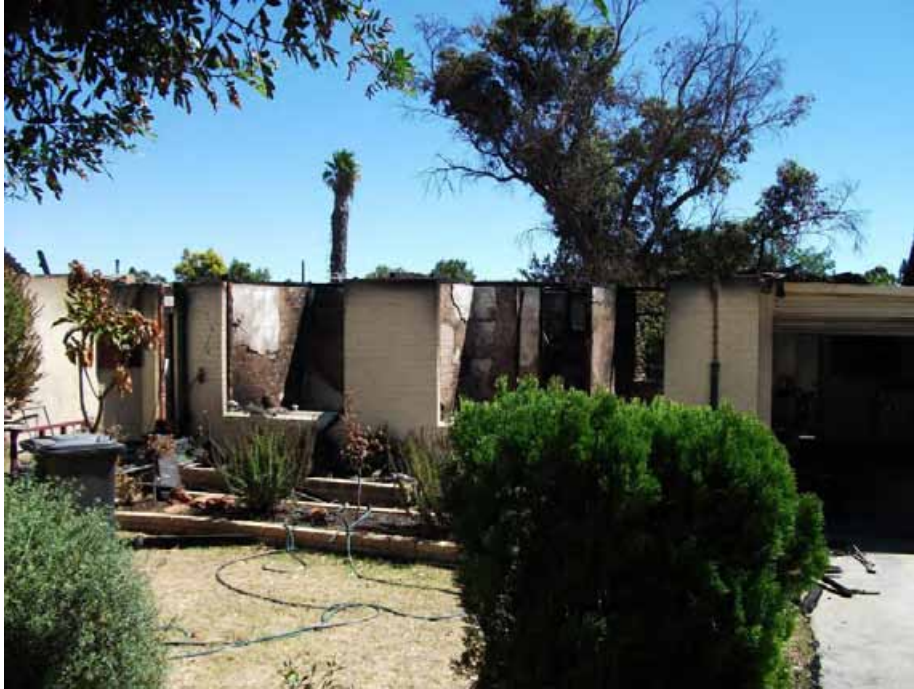
Figure 12: A home destroyed by ember attack. This home was 421 metres from the fire. This home also had a roof mounted evaporative air conditioner

This home (in figure 12) is believed to have been constructed prior to 1999. Another feature of this home was that it was constructed to the basic standard for the era with an elevated wooden floor about 30cm to 45 cm above the ground, and then with limestone blocks around the base of the home. This home was quite some distance (estimated at 421 metres) from the forest or woodland vegetation and could only have been ignited by ember attack.

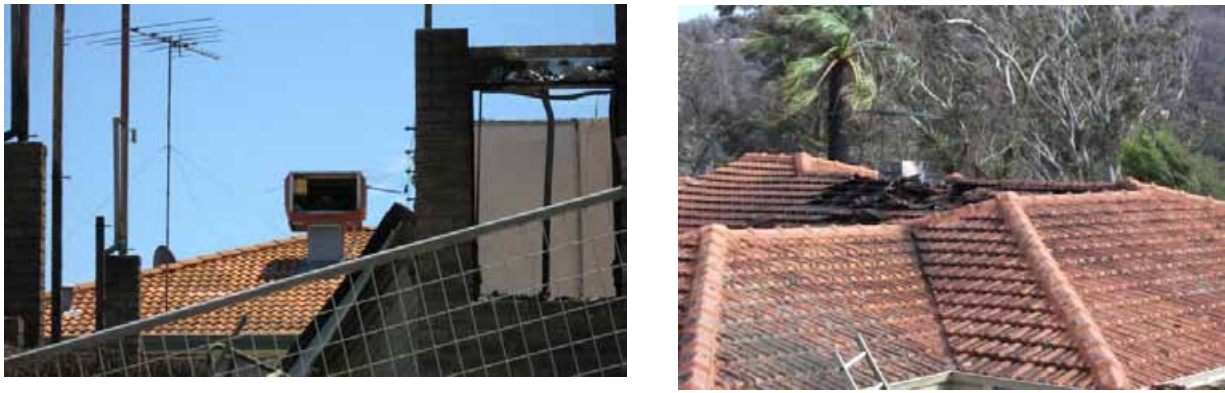
Figure 14: Two further homes with evaporative air conditioners and fire affected

Figures 14 and 15 are indicative of the type of construction for evaporative air conditioners. They are positioned so that air can circulate through wet pads and have the moist air drawn into the house. The method of operation requires air to circulate through the house requiring windows or doors to be partially open during the operation of the unit. By having the unit on top of the house roof exposes the unit to ember attack. Screening the roof mounted units would result in increased protection of the house. This screening should be greater than the minimum 100 metres currently prescribed to optimise the protection of the house.

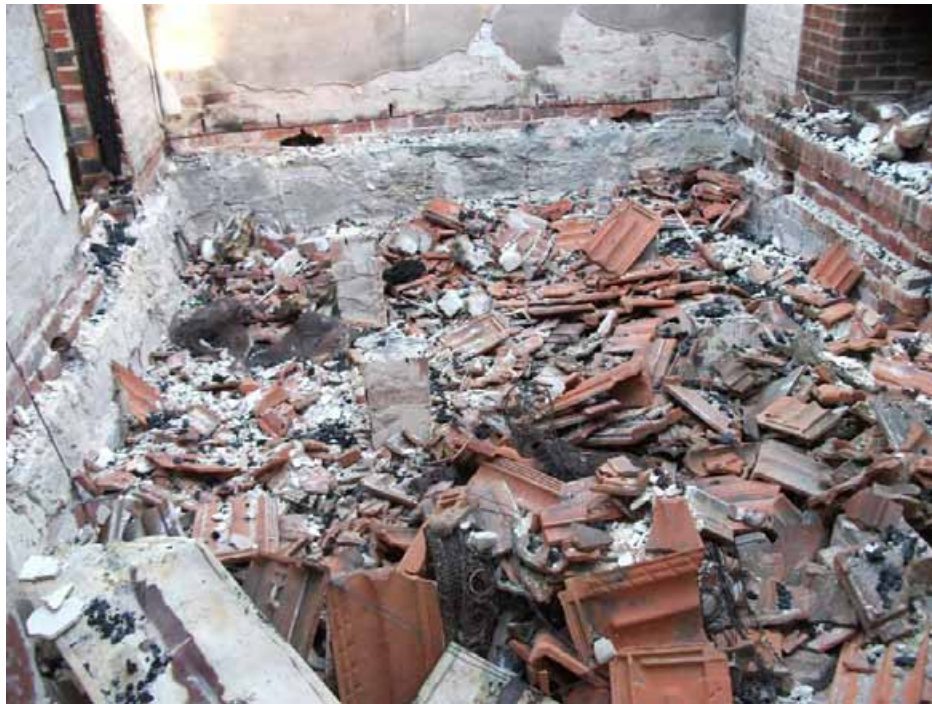
Figure 15: This is indicative of the flooring structure where the floor was wooden and supported around 30-45 cm off the ground

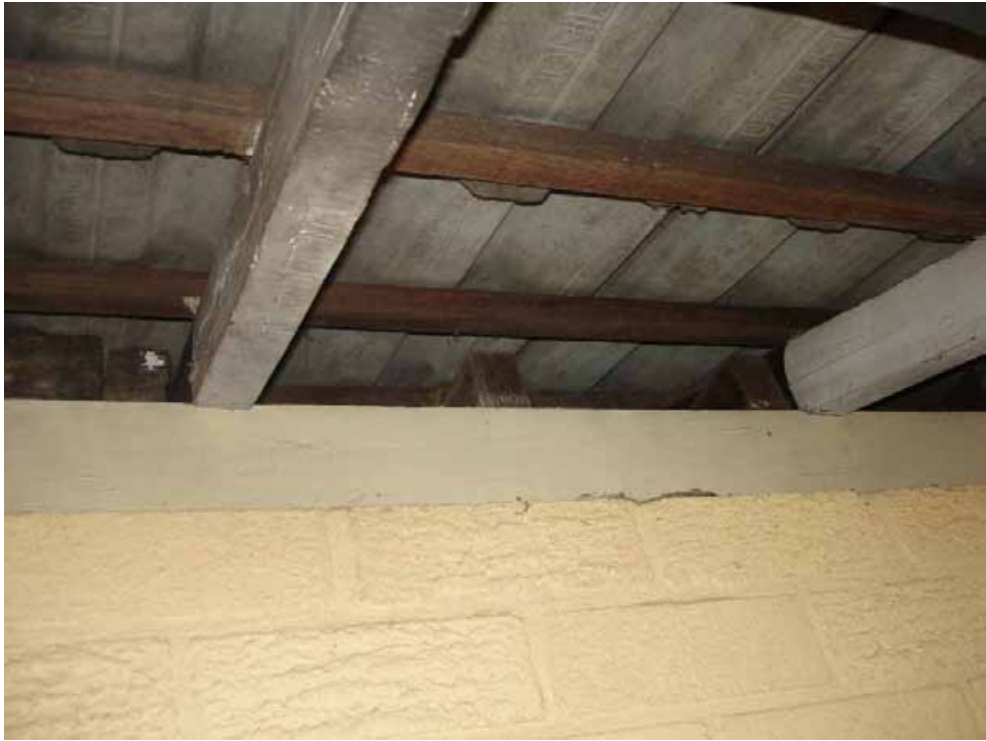
Figure 16 : This home was constructed without ember proofing. This house was on Martin Road and was subject to ember attack.

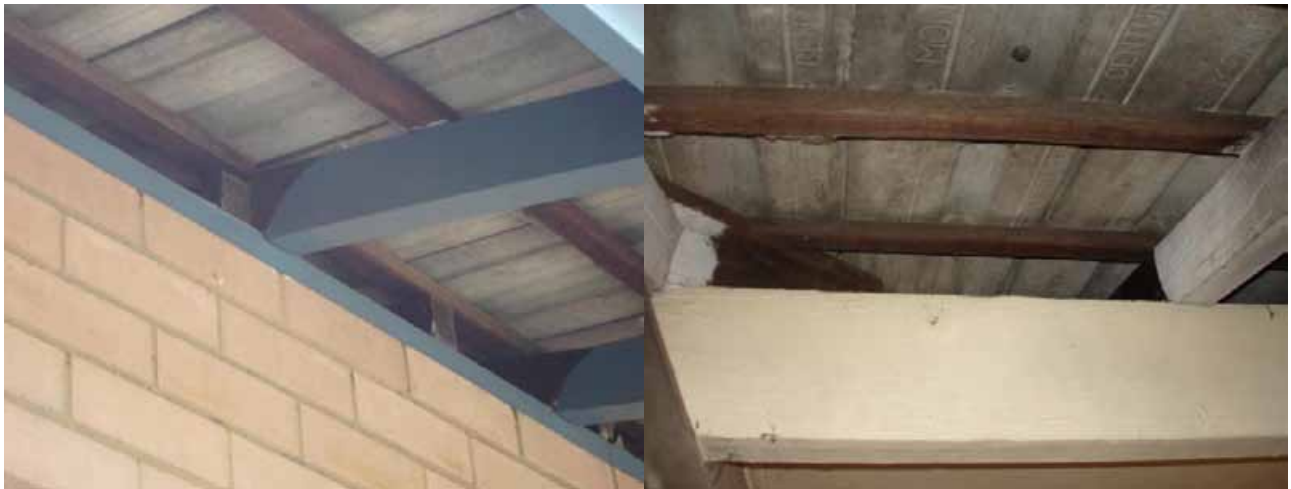
Figure 17: Further examples of the openings between the roof and the ceiling

As previously discussed, this is type of construction, where the roof space is not enclosed, is indicative of the type of construction that facilitated air movement within the space between the roof and the ceiling. It also facilitated the entry of embers into the same space. When coupled together with the evaporative air conditioner it is a potentially catastrophic outcome when a bushfire occurs.

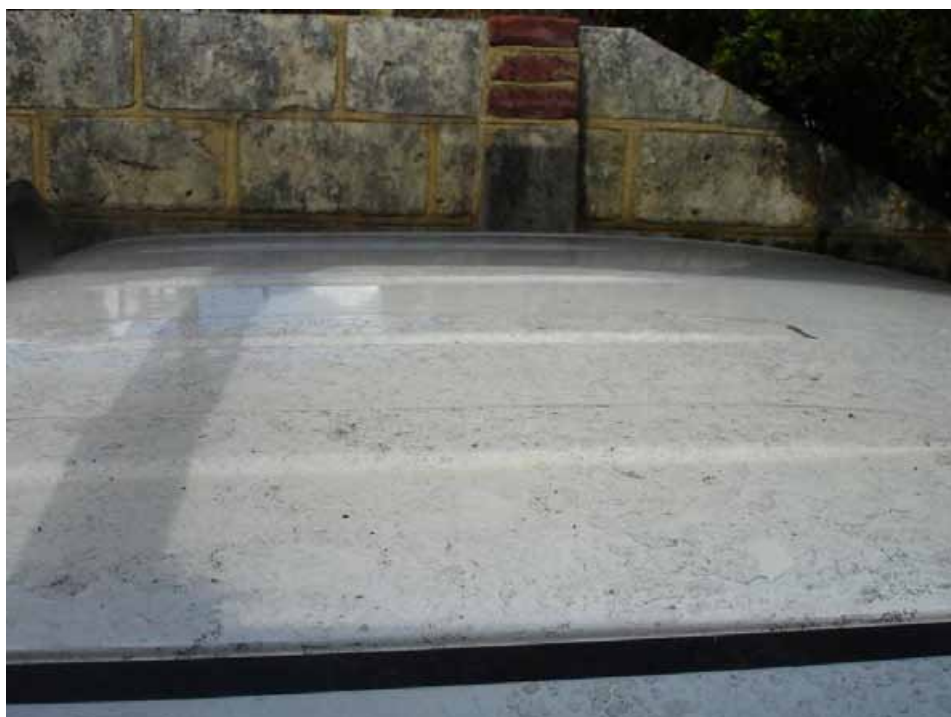
Figure 18 : This is the ember attack on the car parked in the carport on Martin Road

Martin Road is adjacent to the bush and the house is separated from the bush by the road and the set back from the front of the block.

Figures 18 and 19 are indicative of the number of embers that were falling in the Clifton Hills area. As can be clearly identified by the individual burn marks on the car roof and swing, the embers per square metre were very numerous and with sufficient size and ignition potential to cause damage to both items.

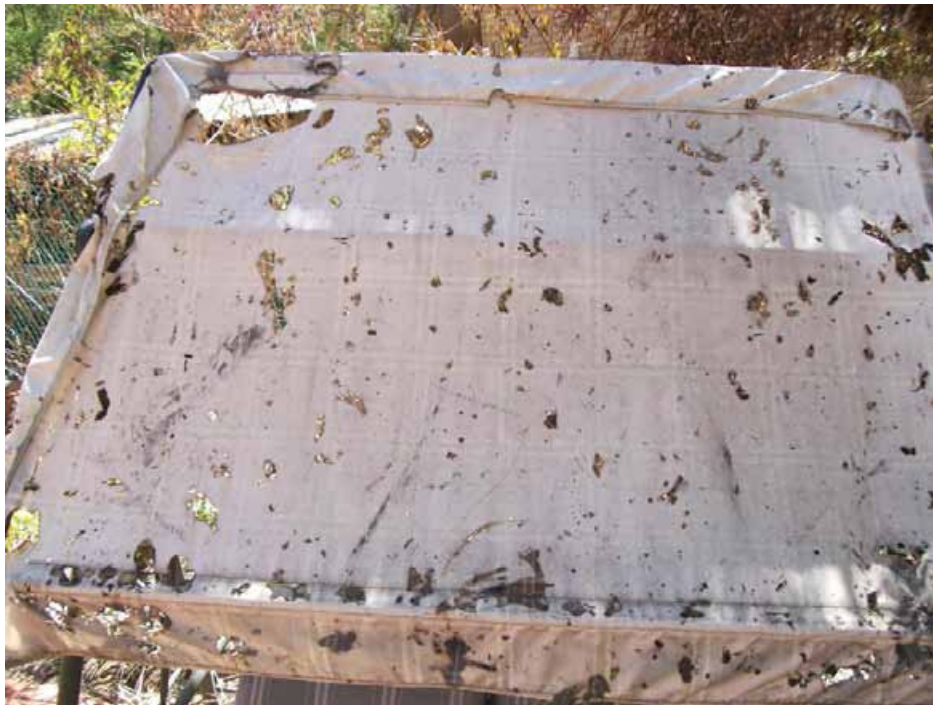
Figure 19 : This is the ember attack on a swing at the rear of a destroyed home in the Clifton Hills area.

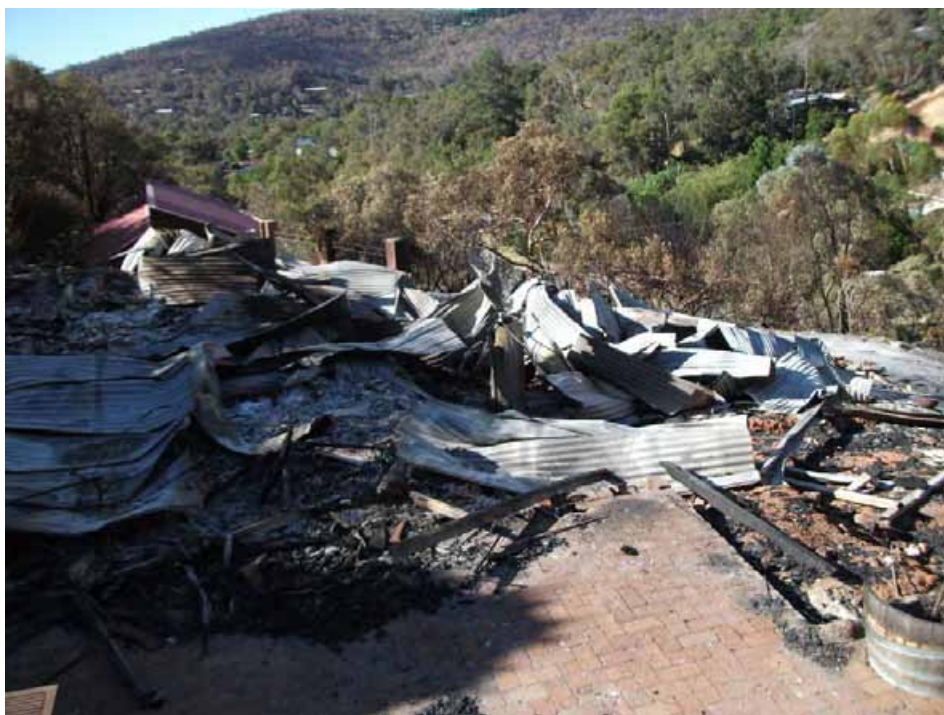
Figure 20: A cedar timber home destroyed following an ember attack

Homes constructed of dry timber are also at risk of being destroyed from flame contact, radiant heat or ember attack. The home in the above photographs (figure 17 and 18) was destroyed, even though the neighbours had tried to suppress the fire and defend the house. It was attacked by embers and burnt to the ground. Figures 17 and 18 provide a pictorial indication of the construction materials and the final outcome for the timber home.

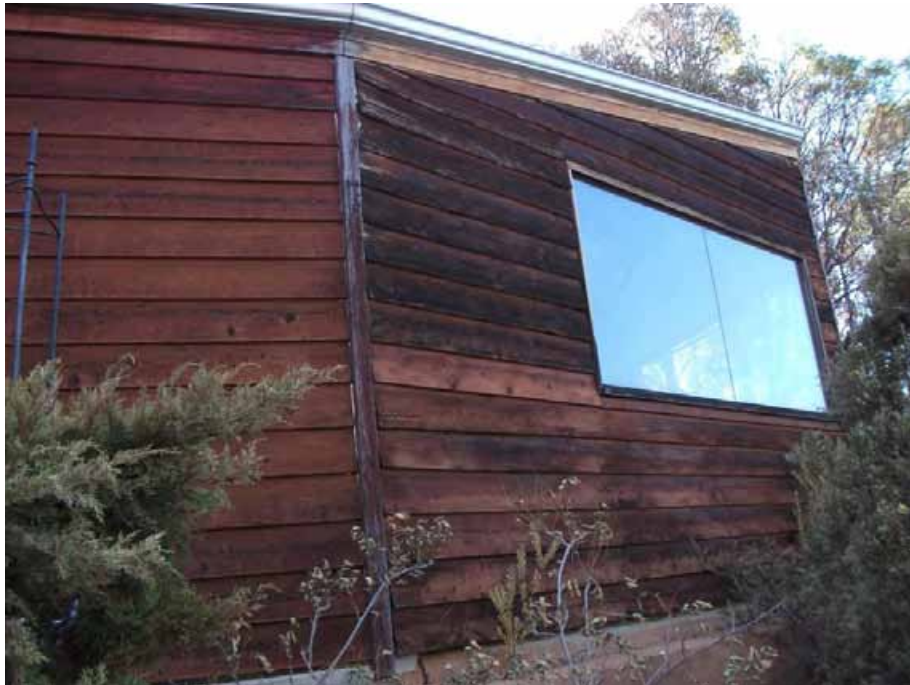
Figure 21: The cedar timber shed on similar construction style and materials adjacent to the destroyed cedar timber home.

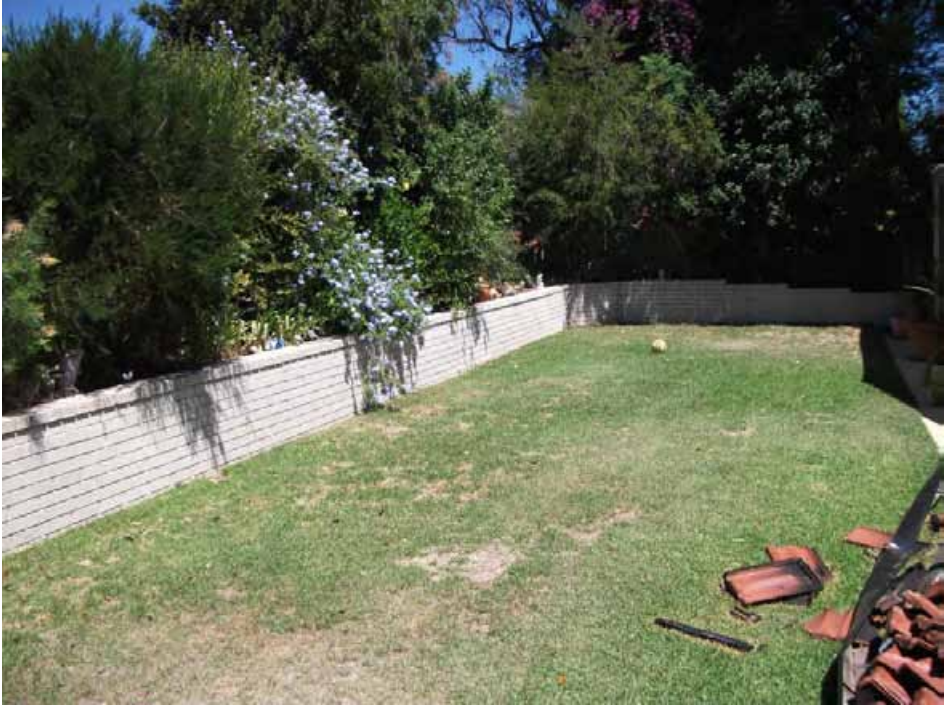
Figure 22: The building protection zone (BPZ) of a home destroyed as consequence of the ember attack

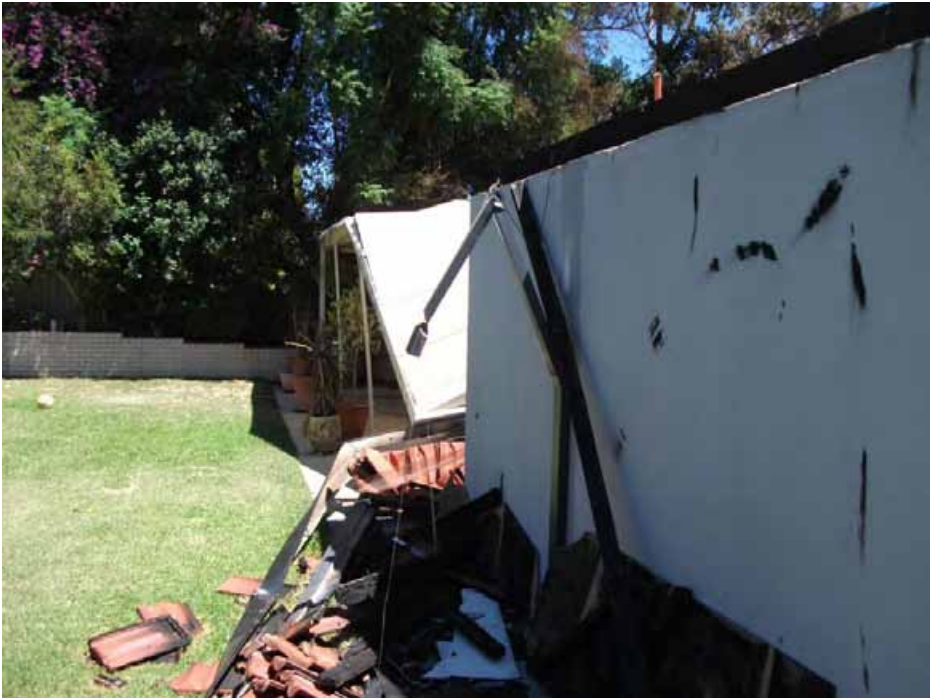
Figure 23: The BPZ closer to the house and the house featured in photograph 19.

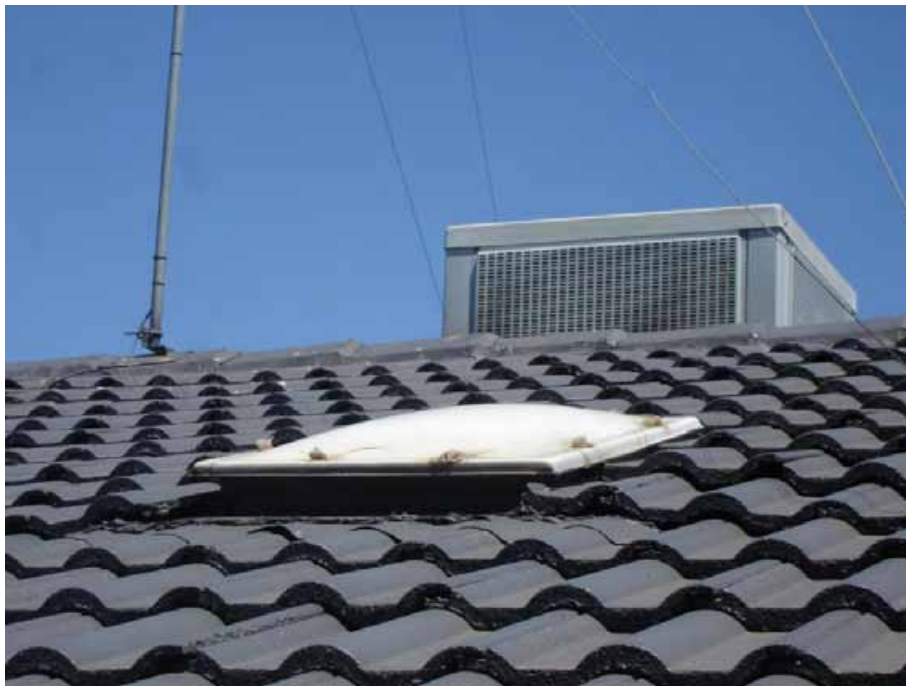
There were also other roof mounted items such as skylights which have been identified in AS 3959 as requiring special attention. This skylight in figure 19 shows some minor damage as a consequence of the embers that fell onto the roof. This home was several streets back from bush interface.

Figure 25: Ember caused damage to a sky light

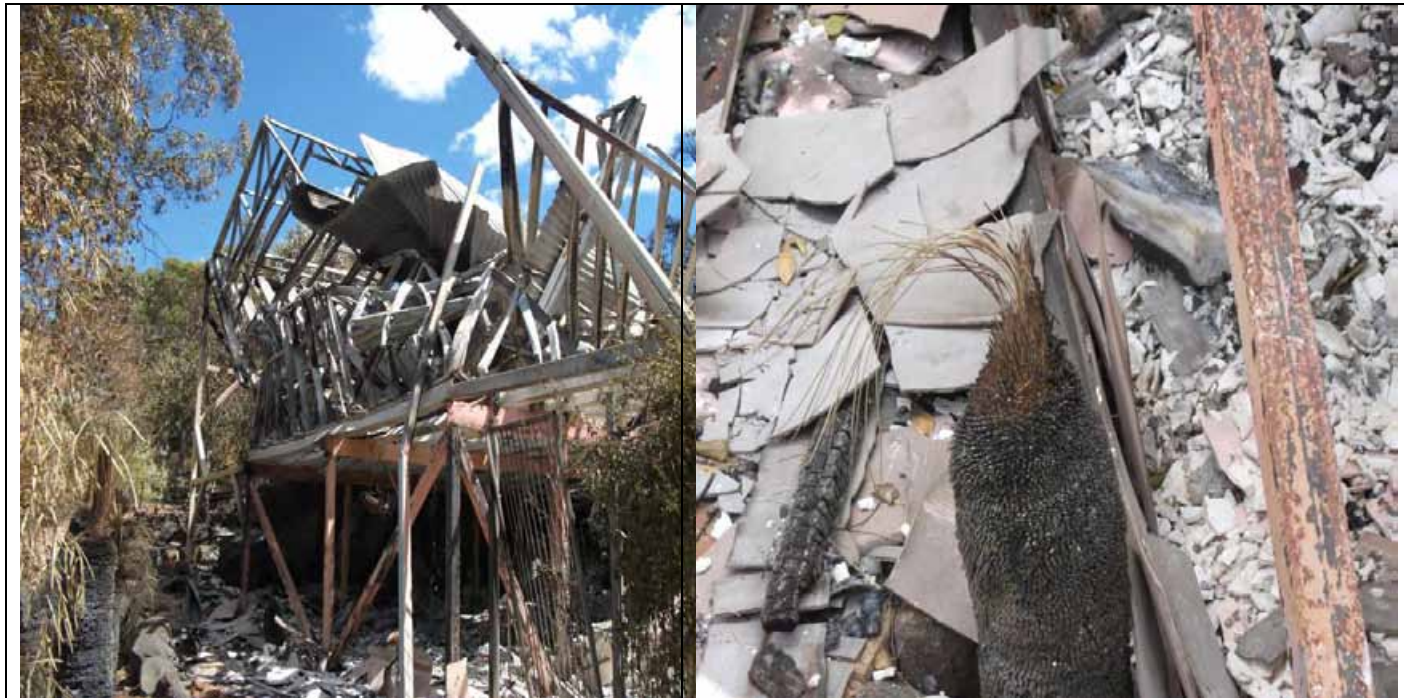
The external wall construction materials appear to be a significant contributor as to whether the house was destroyed if the walls were constructed of cellulose cement. The cellulose cement walls appear to be susceptible to direct flame contact and radiant heat. AS 3959 prescribes that the fibre-cement external cladding should be a minimum of 6mm for BAL -12.5 upwards. This fire's destruction associated with the direct flame contact and radiant heat on cellulose cement walls appears to be a problem.

Figure 27: House constructed with cellulose cement cladding

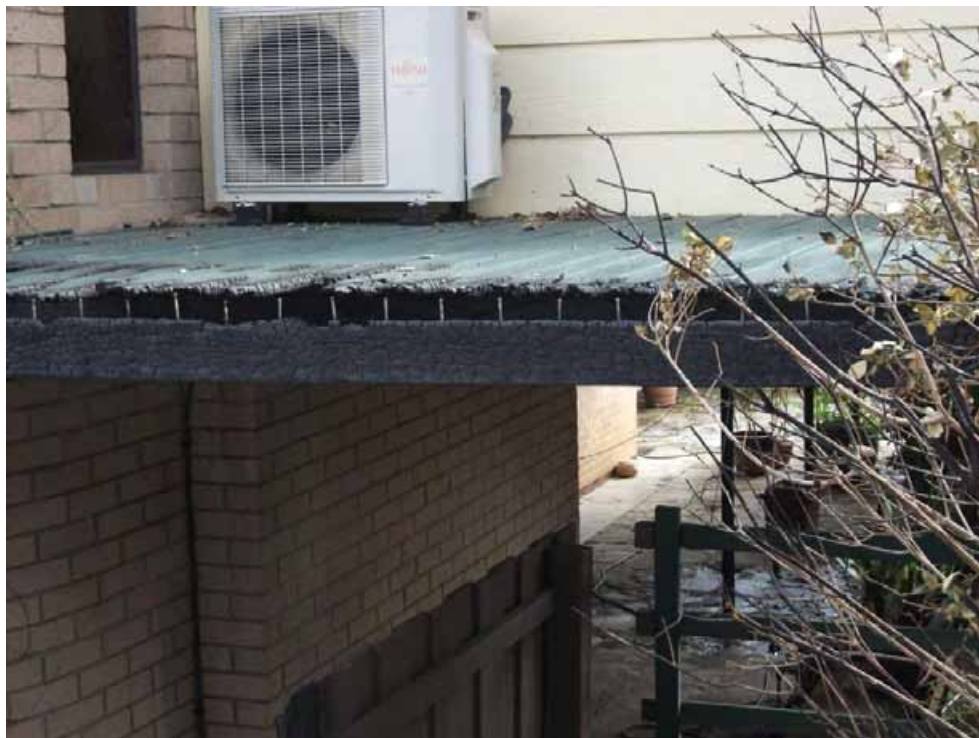
Figure 31 is indicative of some of the damage that resulted from having tall plants adjacent to the building. In a number of cases as a consequence of the plant location the bushfire caused direct flame contact onto the home.

Figure 31: House damage following the tall plants igniting and putting direct flame contact onto the house

The fire ran towards the house from the right of the photograph in figure 31. There are no fences or barriers to prevent the radiant heat or direct flame contact impacting directly onto the home. The fuel load was partially managed with some owner intervention immediately adjacent to the home, but diminishing further out from the home. This type of fuel load management in many areas of the fire affected locations was fairly consistent as a theoretical approach, but not uniformly applied to the level as recommended by FESA. This home backed onto the landscape zone that was subject to the defoliation near Canning Mills Road as indicated in photographs 3 and 4.

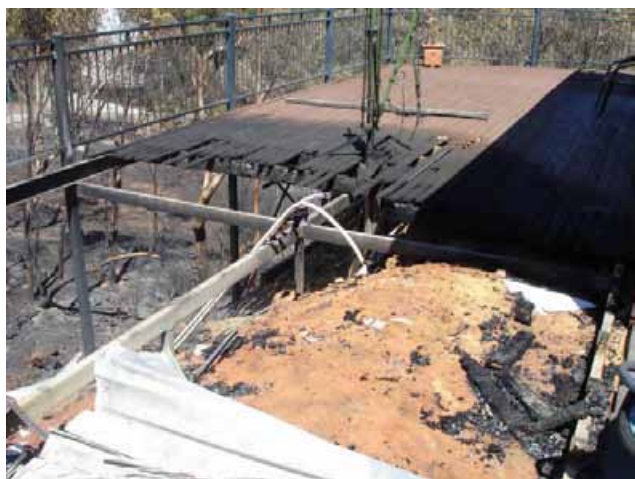
Figure 32: Shows the deck damage

These photographs (photographs 32 and 33) show the impact of the flame and heat induced from the burning deck and subsequent impact on the cement sheet. The cement sheet has cracked and then broken, exposing a portion of gap in the roof space. This gap then creates an opening for embers, radiant heat or direct flame contact to enter the roof space and ignite any suitable fuels. The cracking and breaking of narrow cement sheets appears to be a fairly consistent outcome when these products are exposed to reasonable levels of radiant heat or direct flame contact.

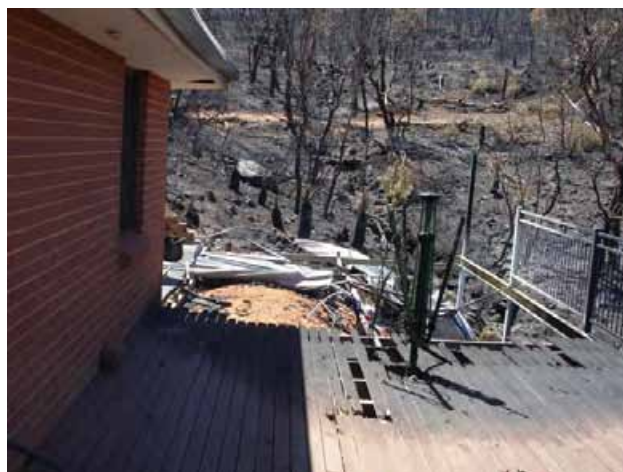
Figure 33: Shows the deck damage and BPZ vegetation structure

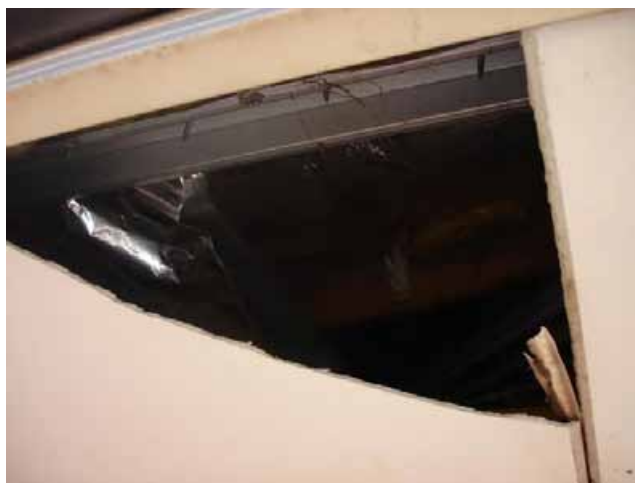
Figure 34: Shows the broken cement sheet

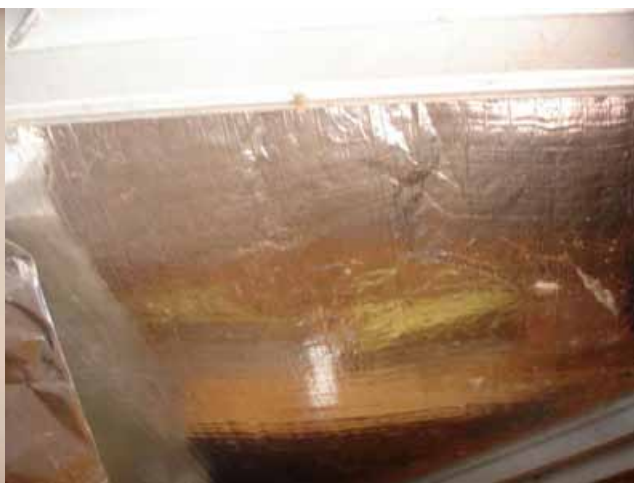
Figure 35: Shows the sarking through the broken cement sheet

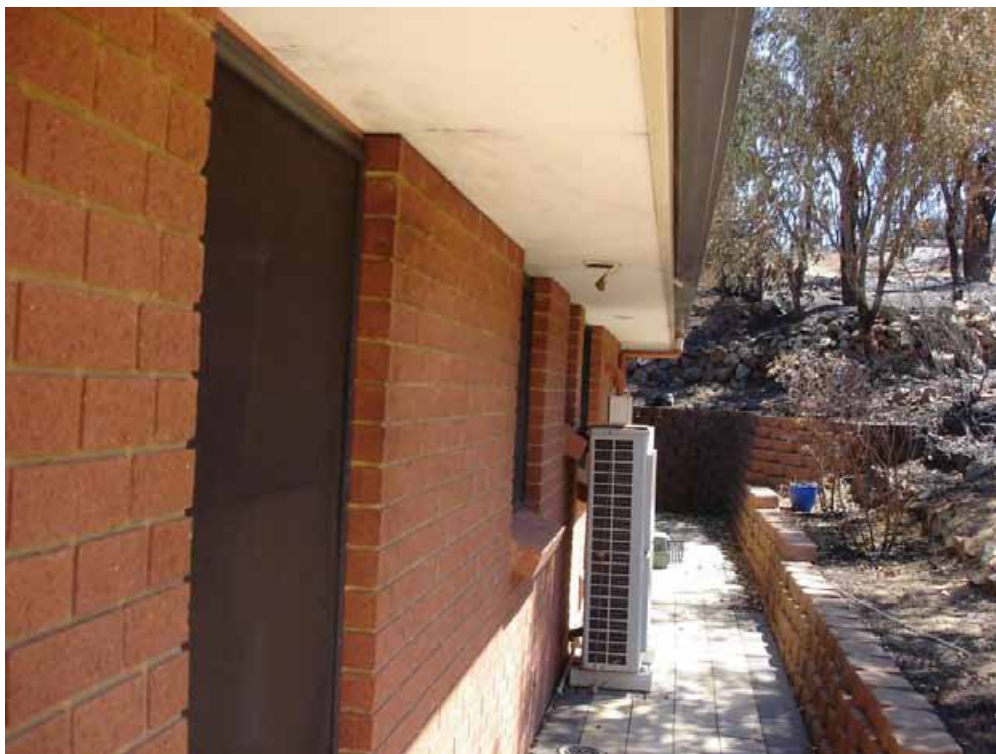
In the photographs below (photograph 27 and 28) you can see the impact of the radiant heat with the melting of the air vent, the reduced fuel load near the retaining wall and the benefits of having the patch between the home and the bush.

Photograph 36: The view along the home adjacent to the bush.

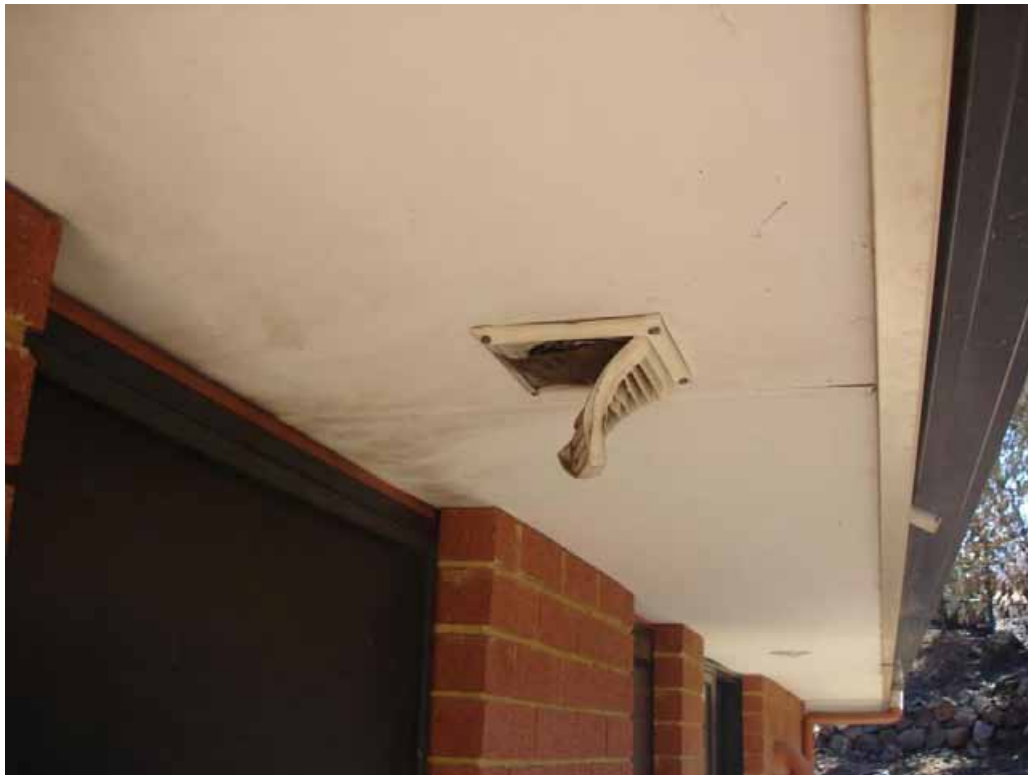
Photograph 37: The melted air vent and smoke staining on the eaves.

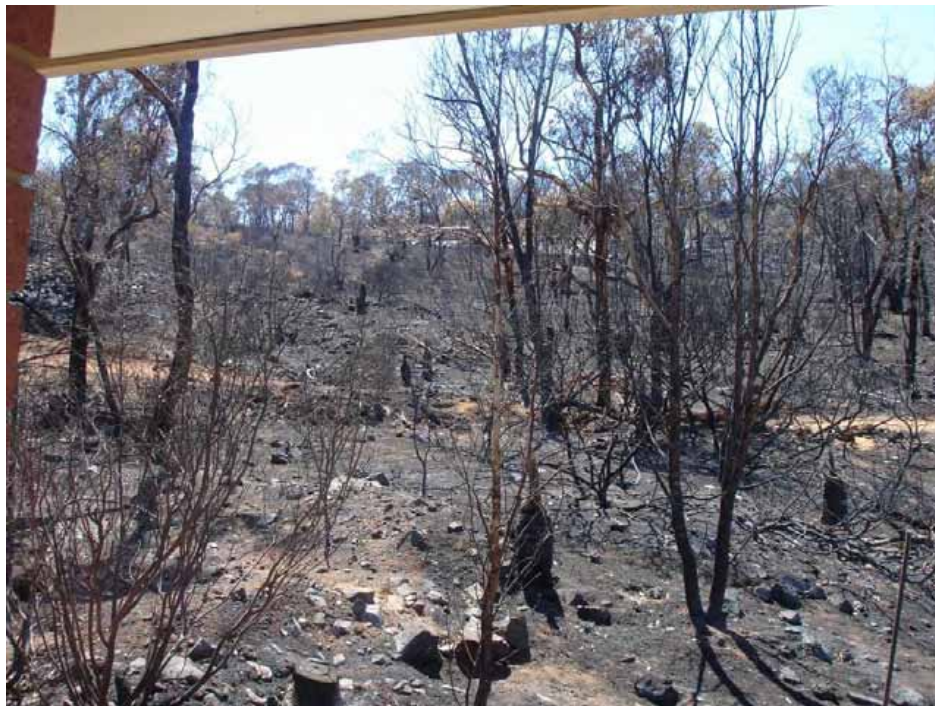
This increase in bushfire attack level is critical in the survivability of the house. As can be seen from the following photographs the fuel load and fuel structure in the BPZ was continuous and at a fuel load that posed a risk to the survivability of the house. Across the fire zone the fuel loads were generally excessive for the level of standard for the houses that were constructed.

Photograph 39: This is the view of the BPZ and HSZ from near to the house

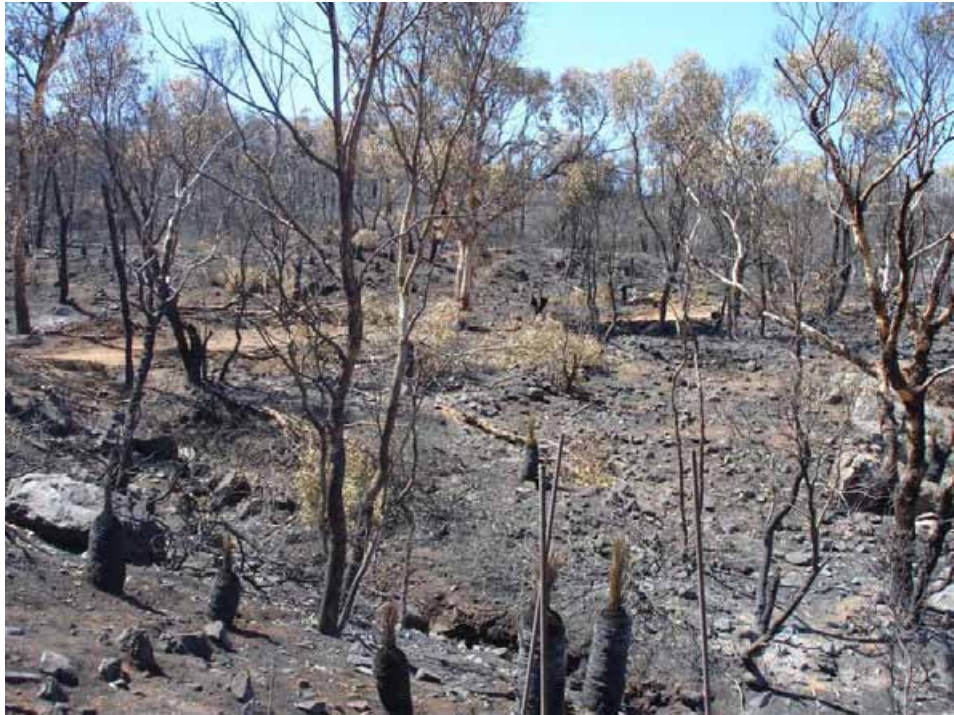
Photograph 40: This is the view of the BPZ and HSZ from near to the deck

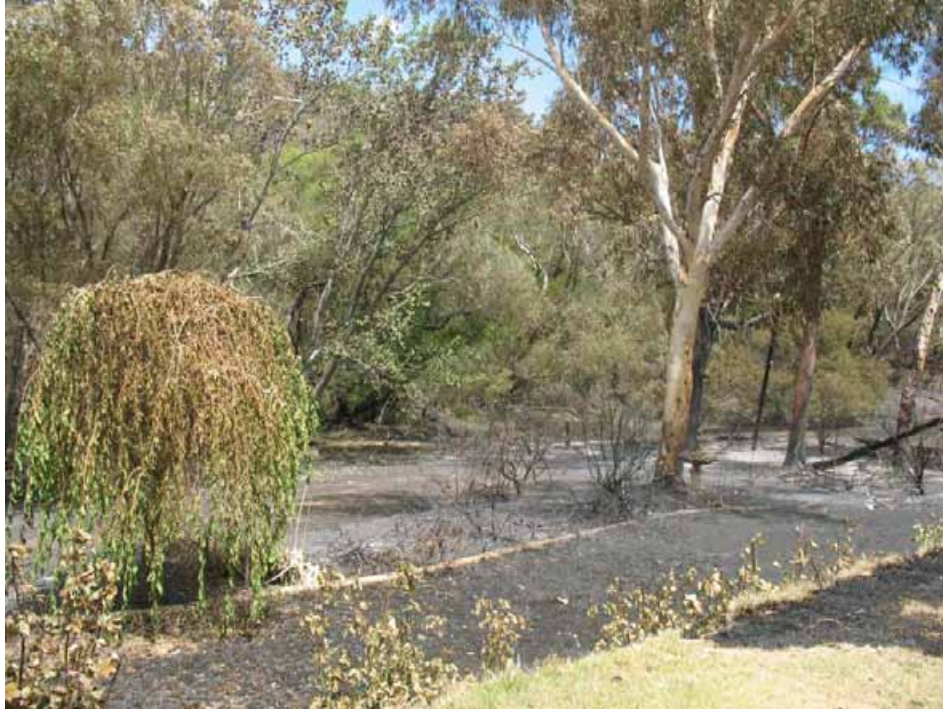
Figure 46: Indicative fuel structure in the HSZ adjacent to a home that was destroyed

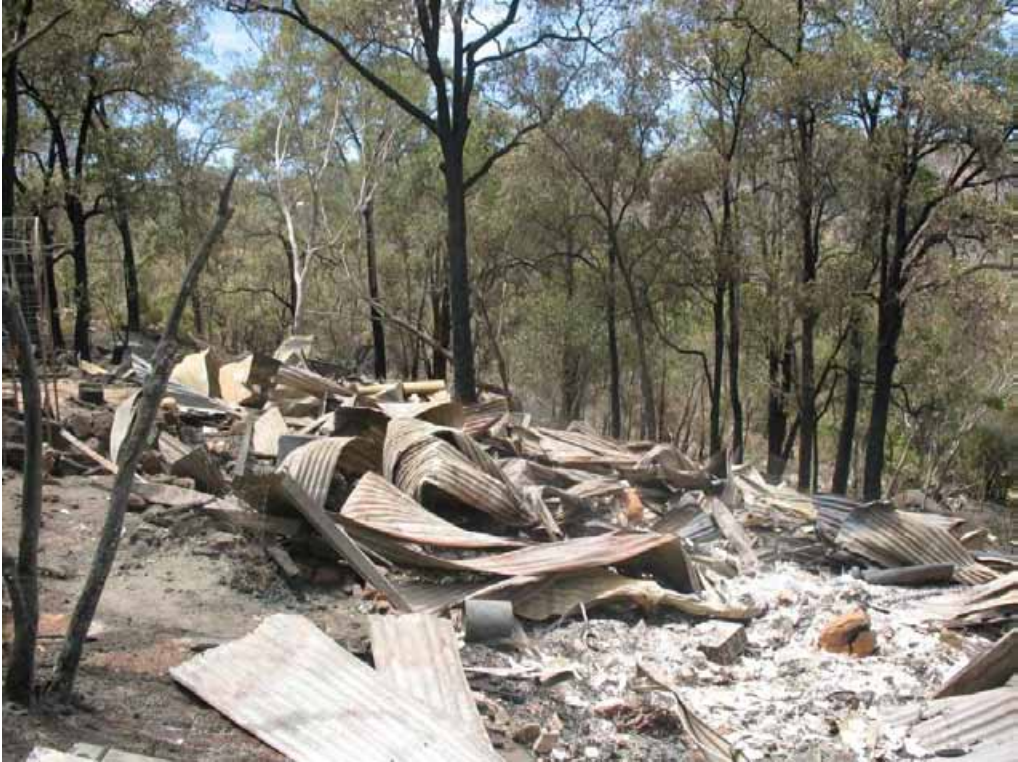
Figure 47 shows the impact of the fire on a home with a corrugated iron roof. The entire home is destroyed and burnt to the ground. The tree crowns are intact and only partially scorched indicating that the fire rate of spread and intensity was not great. As the site has not been burnt for a number of years the volume of embers would have been significant. Research conducted by Ellis¹⁵ and presented in 2003 indicates that for an older jarrah forest fuel there can be a marked increase in the number of viable embers being generated and these embers may travel further than for a younger fuel in the jarrah forest fuel type.

Figure 47: Indicative fire impact in the HSZ adjacent to a home that was destroyed

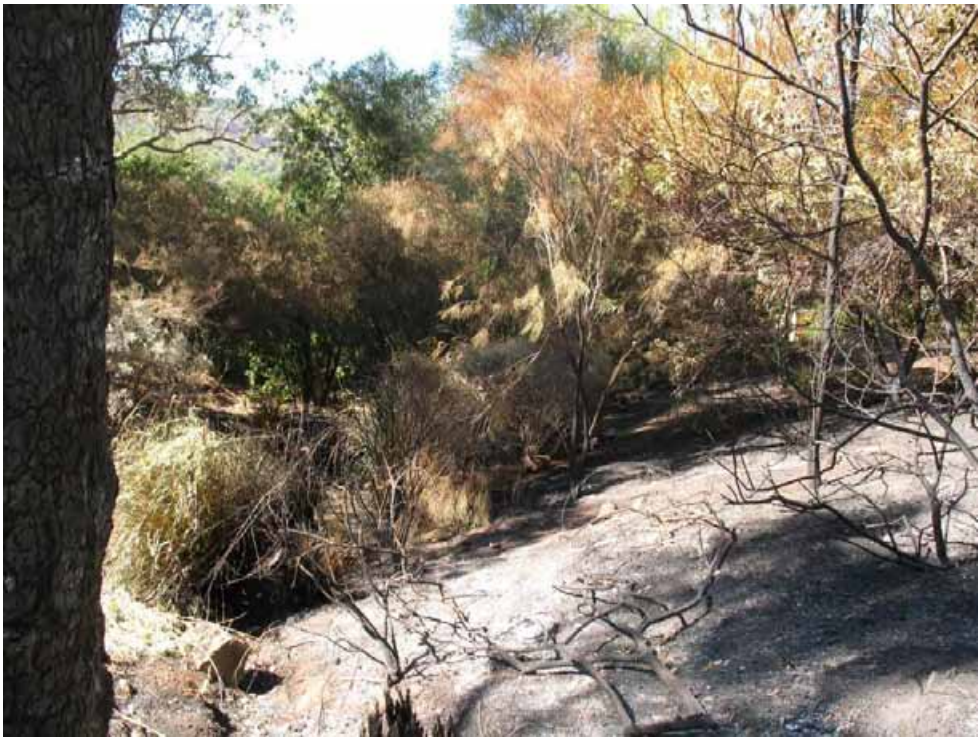
Figure 48: Indicative fuel structure in the HSZ adjacent to home that was destroyed
